DAN HOLE POND DAM

NH 00376

PHASE I INSPECTION REPORT
NATIONAL DAM INSPECTION PROGRAM

NOVEMBER 1978

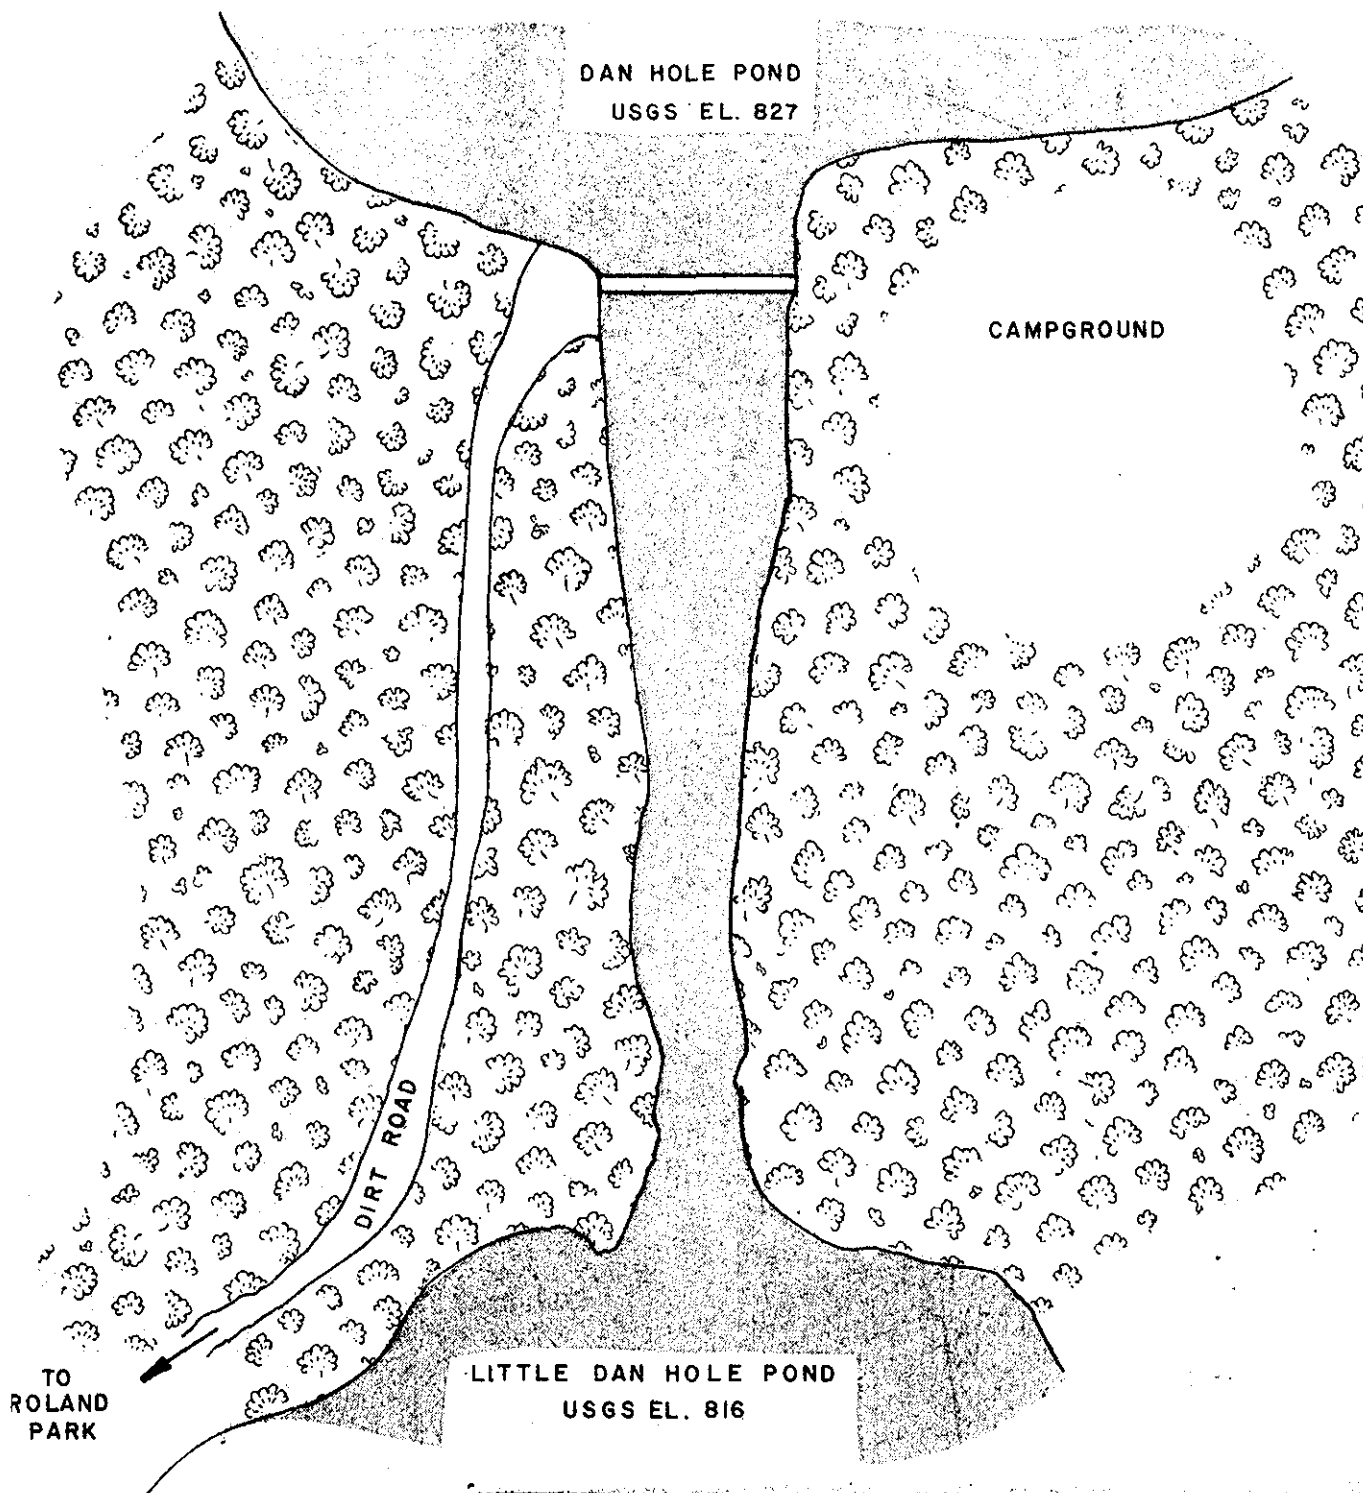
The dam is located approximately 3 miles southwest of the village of Center Ossipee on Route 16. The site, which is at the junction of Dan Hole Pond and Little Dan Hole Pond, is accessible by taking Eldrige Road approximately 1.7 miles from Doors Corner to the tennis court and then turning right into the woods on a heavily overgrown dirt road. The portion of the USGS Wolfeboro, N.H. quadrangle presented on page viii shows this locus. Figure 1 of Appendix B presents a site plan developed from the map and the site inspection.

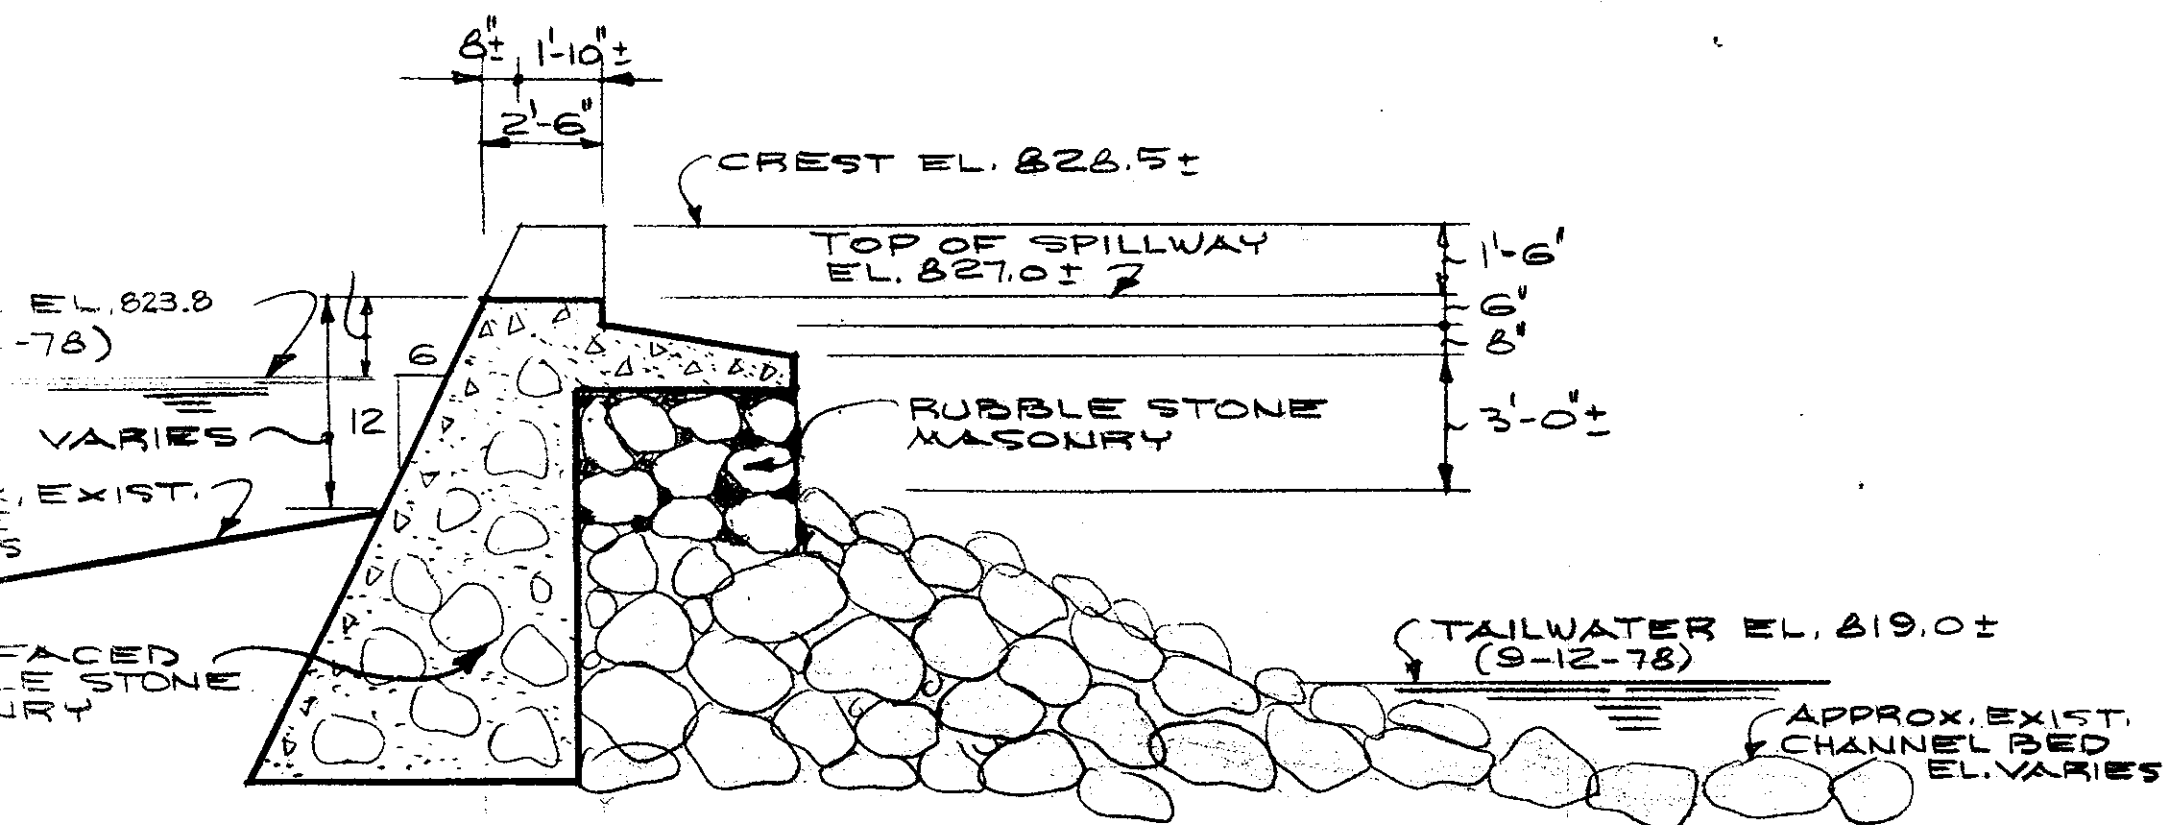
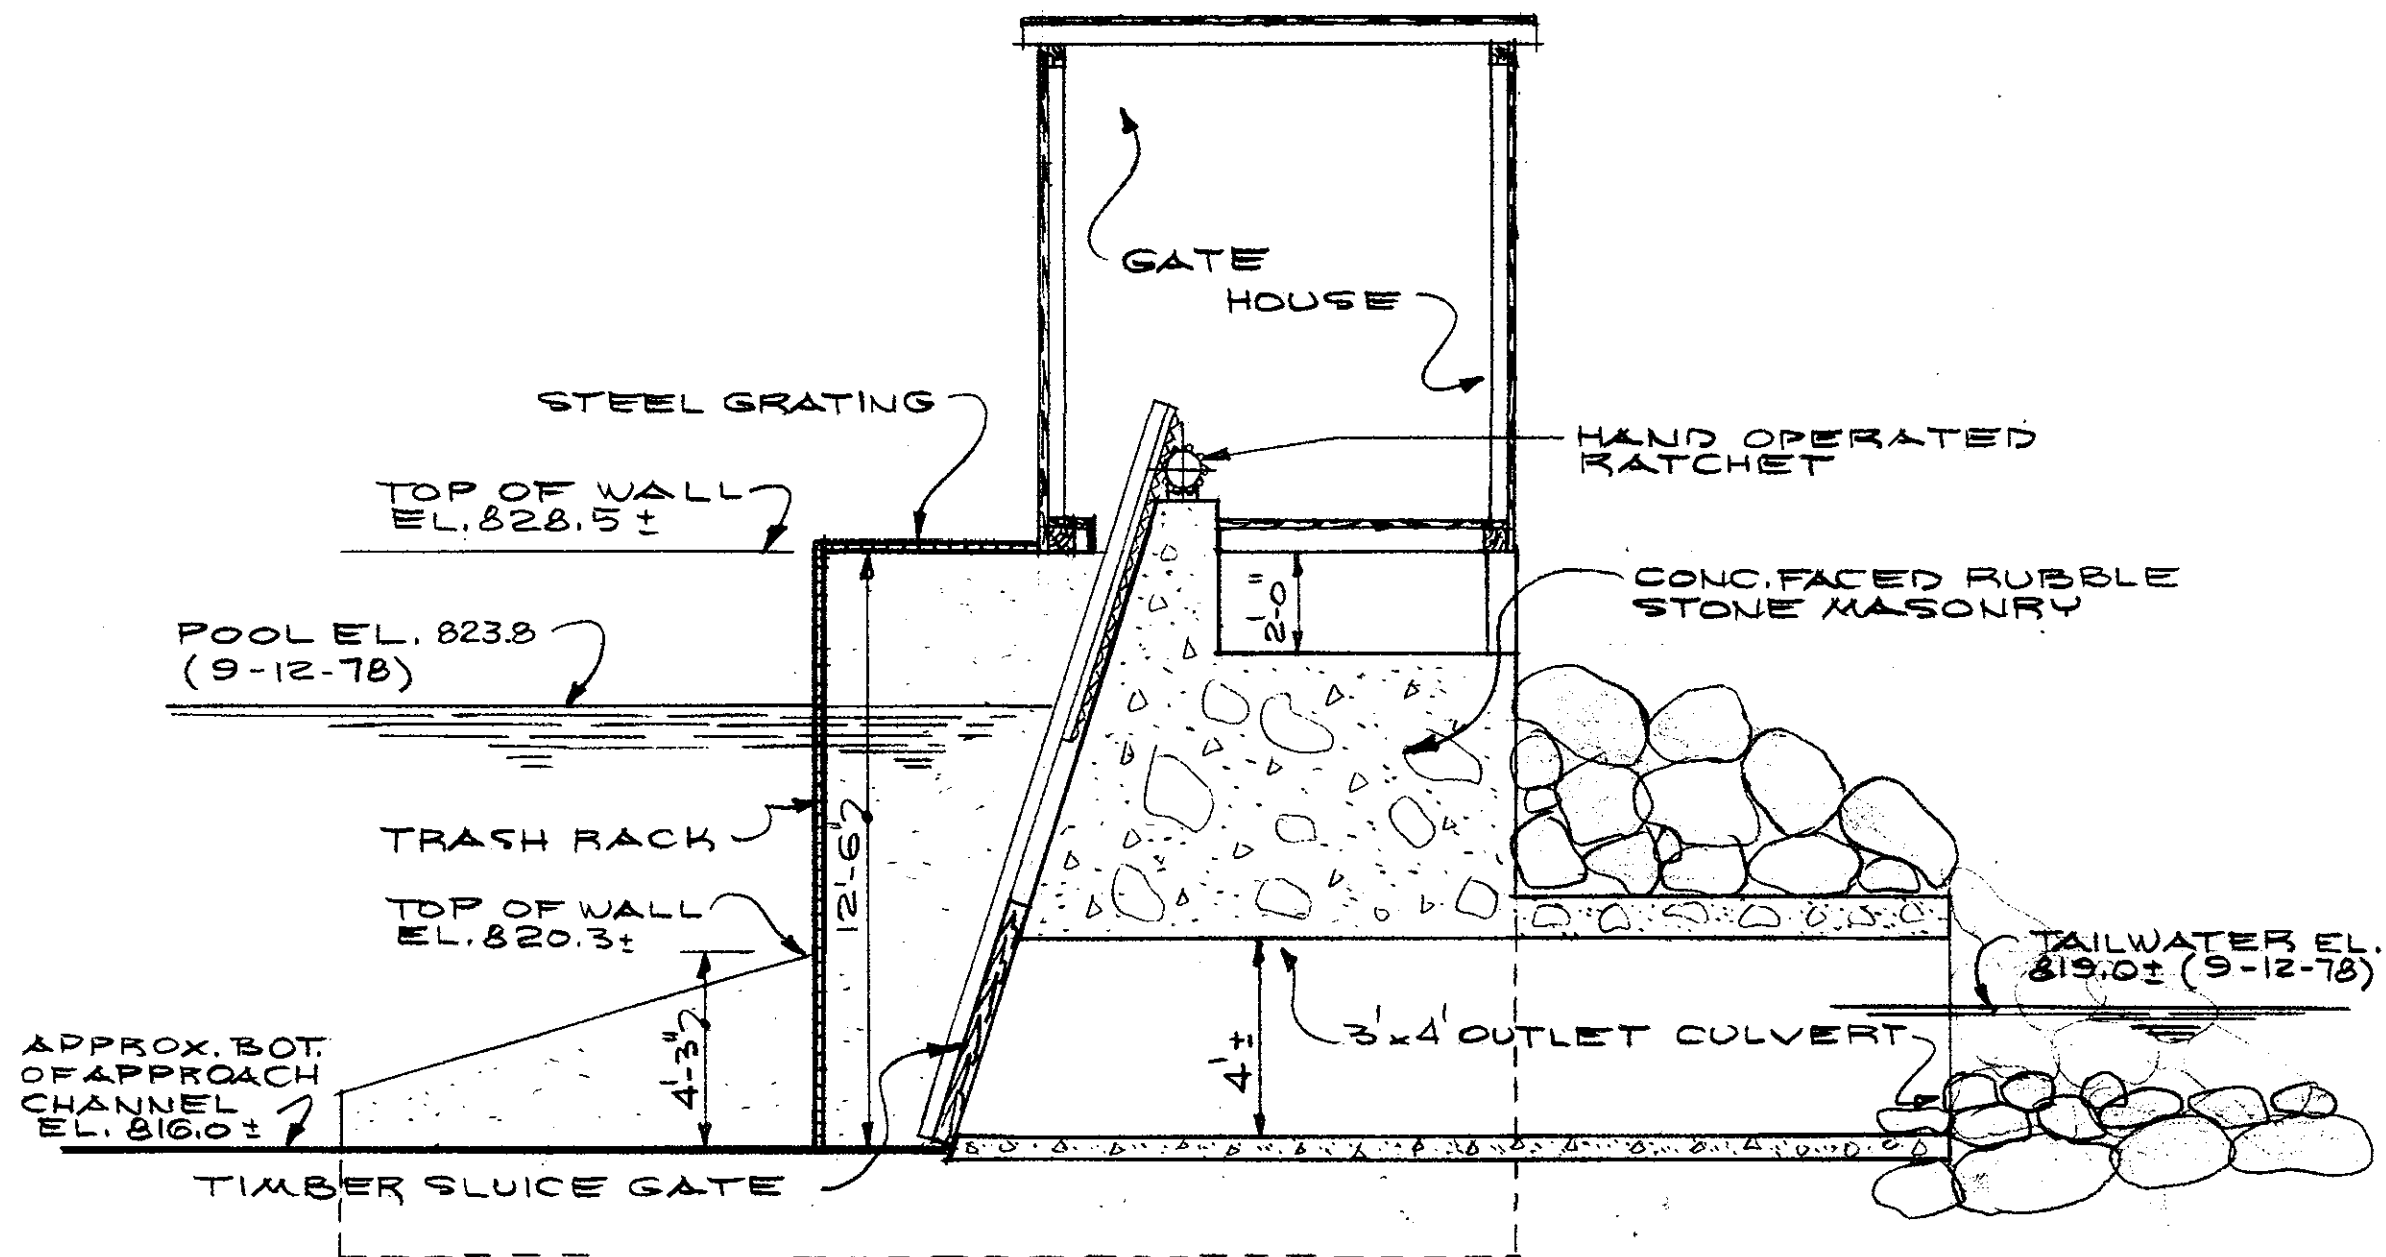
This dam is a concrete faced, cemented stone masonry gravity structure 114 feet long (Fig. 2). The downstream side of the dam is buttressed with dumped boulders (Fig. 3). A gate house located midway along the length of the dam divides a broad crested spillway, 21 feet long to the right of the structure and 33.5 feet long to the left. The top of the spillway is 1.5 feet below the dam crest. While the dam does contain stanchions for flashboards, this feature is not used. A wooden catwalk spans over the right spillway for access to the gate house. Foundation conditions at the site are not apparent. The dam has a maximum height of approximately 12.5 feet above the channel.
